## Construction Progress Report

| Property | SAMPLE - Hollow Creek Commerce Park, Lot 3 |
| Project ID | GT-2026-1042 |

This report documents visible construction progress observed in supplied aerial imagery and supports dated progress records and comparison between visits.

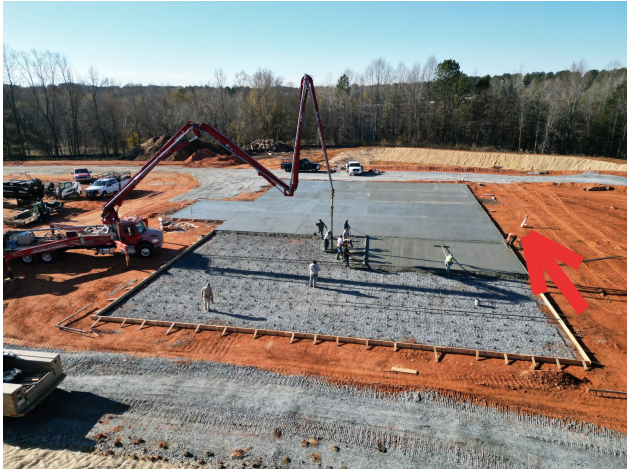
F1 — Drainage / East edge of pad — Review

| Priority Observation | Suggested Follow-Up |
|---|---|
| F1 — Drainage / East edge of pad: Bare soil along the east edge appears unstabilized, and runoff channels are visible. | 30 Days: Have temporary stabilization and perimeter controls checked. |

| ID | Item | Owner | Due | Status |
|---|---|---|---|---|
| F1 | East edge of pad: Bare soil along the east edge appears unstabilized, and runoff channels are visible. | Site superintendent | 2026-10-15 | Open |

| Observation | Bare soil along the east edge appears unstabilized, and runoff channels are visible. |
| Potential concern | Rain could carry sediment toward the lower side of the site. |

| Recommended action | Have temporary stabilization and perimeter controls checked. |

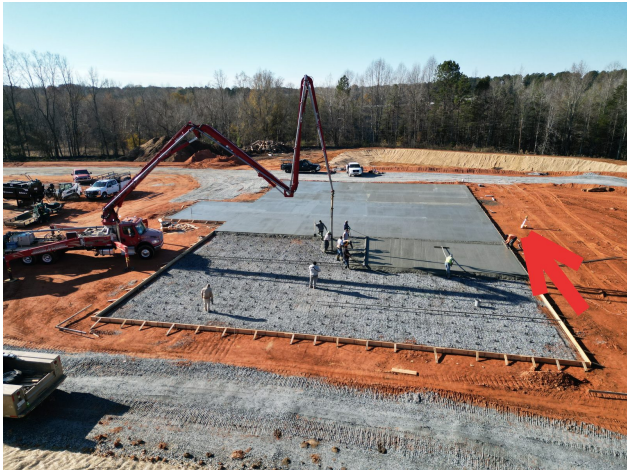
F2 — Site / Building pad — Good

| Priority Observation | Suggested Follow-Up |
|---|---|
| F2 — Site / Building pad: Concrete placement appears to be underway across the pad, with finishing in progress. | No Action: Continue to document at the next visit. |

| Observation | Concrete placement appears to be underway across the pad, with finishing in progress. |

| Recommended action | Continue to document at the next visit. |
